QUICK RESPONSE USING FORENSIC ENGINEERING ON STRUCTURAL BUILDING DAMAGE

ABSTRACT

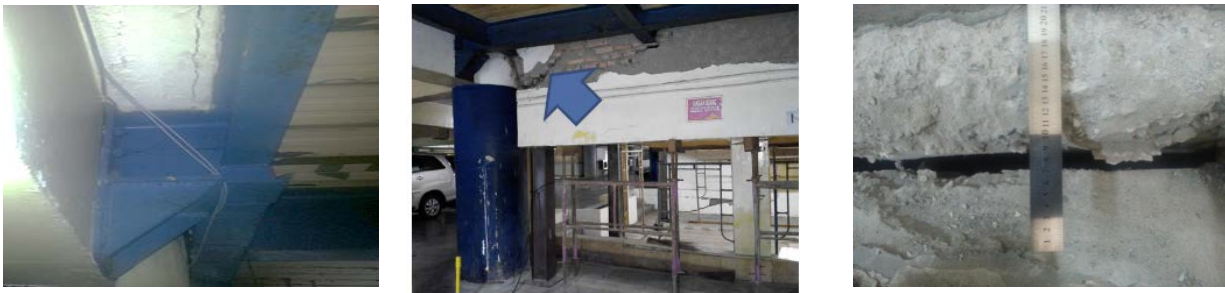
The damage to the existing building structure is presented visually in Figure 2 and torsion is observed in the boundary beam between the old and new buildings due to the fact that the steel beams of the new buildings are connected to the old buildings beams instead of the columns. This has the ability to cause cracks in the slabs around the beams in the border area while the upper bolts at the steel beam joints in the new building as well as the old beams experience tension and look uneven as shown in Figure 2.

Figure 2. Damage to the upper structure

The visual results also showed shear cracks in the beams due to lack of connection to the column as well as the occurrence of non-uniform subsidence in the foundation as observed with the deformation in the basement floor, damage to brick walls, and broken slabs in the dilated area between the main and annex buildings.

The cause of the damage was triggered by a new project in dewatering work, near the building being investigated. The evidence is that there are eight buildings that suffered similar damage.

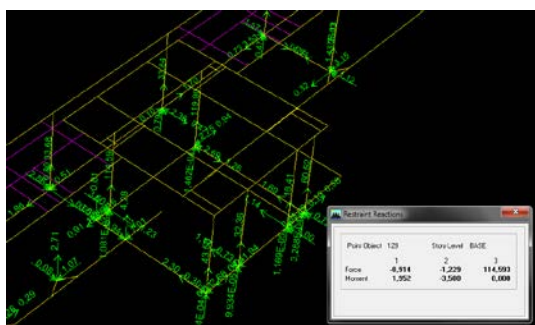
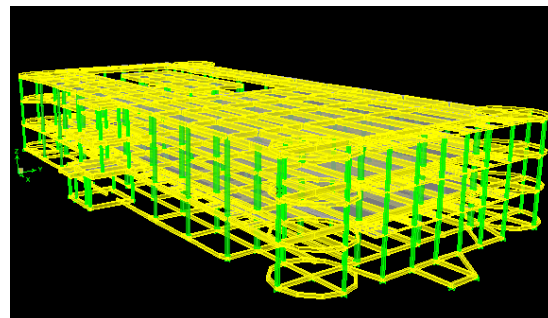
Figure 3. Modeling of the building structures due to gravity loads

The ultimate torsion load condition on the boundary beam due to the mounting of the new building's steel beam on the old building's concrete beam was observed to have led to the twisting which caused the cracks in the slabs. Moreover, an improper structural system was observed to have caused an uneven load distribution mechanism and this made certain columns to be heavy while others are much lighter. In this case, one column has an ultimate axial load of 114 tons while the surrounding columns are

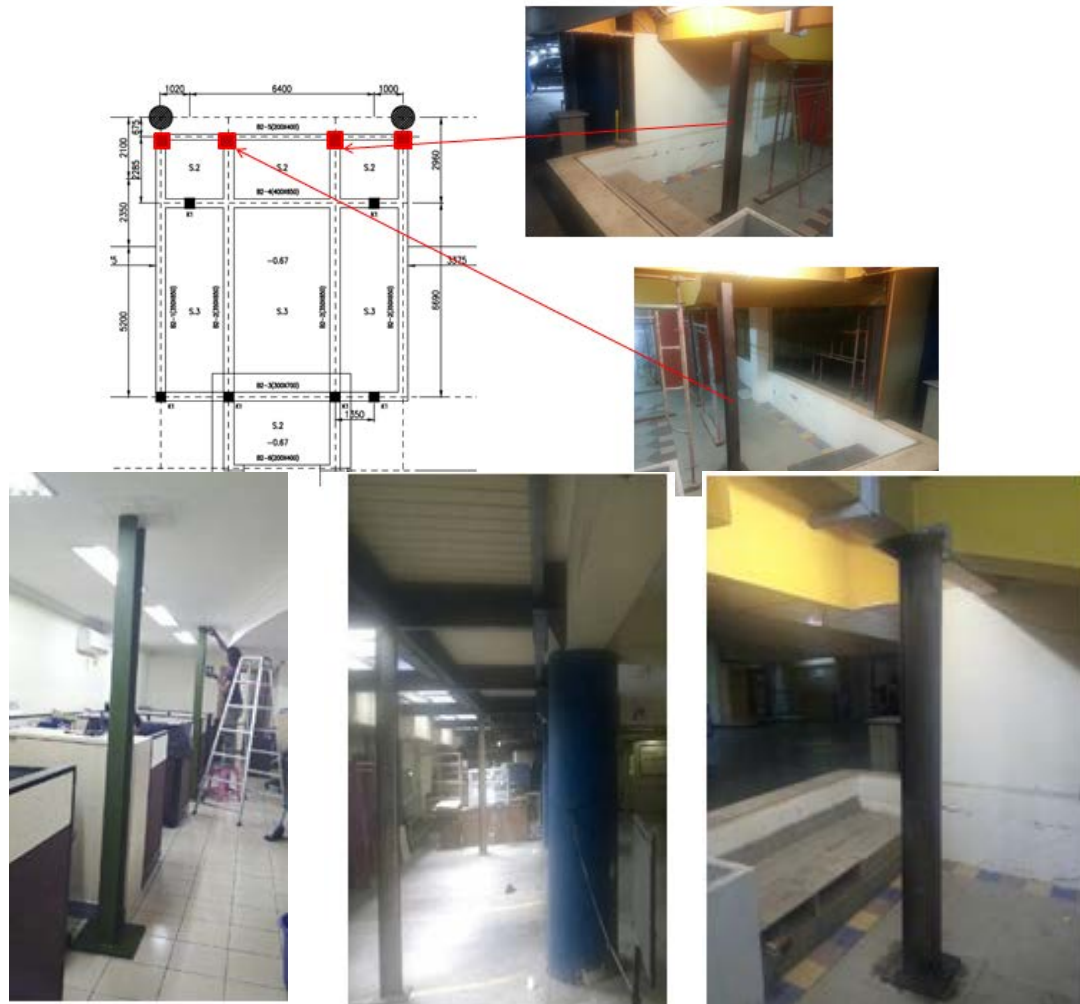
Figure 4. Temporary strengthening of the basement floor

These were placed in the basement at the lobby area as well as the right and left wings of the lobby as shown in Figure 4.

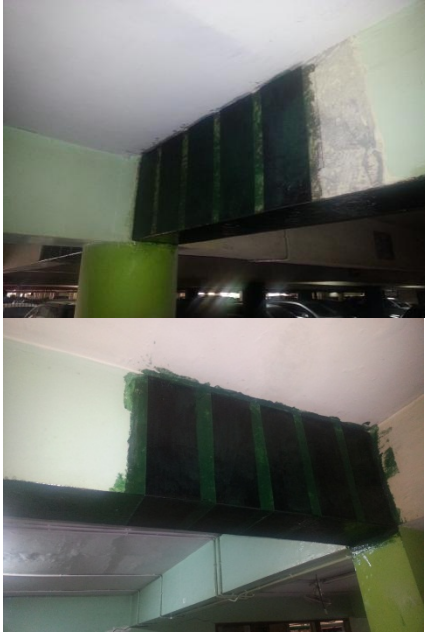
The beams in the basement are cracked as a result of the transfer due to the lack of support from the column as shown in Figure 5. Therefore, FRP was used as the strengthening material due to its lightness, high stiffness, corrosion resistance, fast installation, and low maintenance costs.

Figure 5. FRP strengthening of beam on first floor.

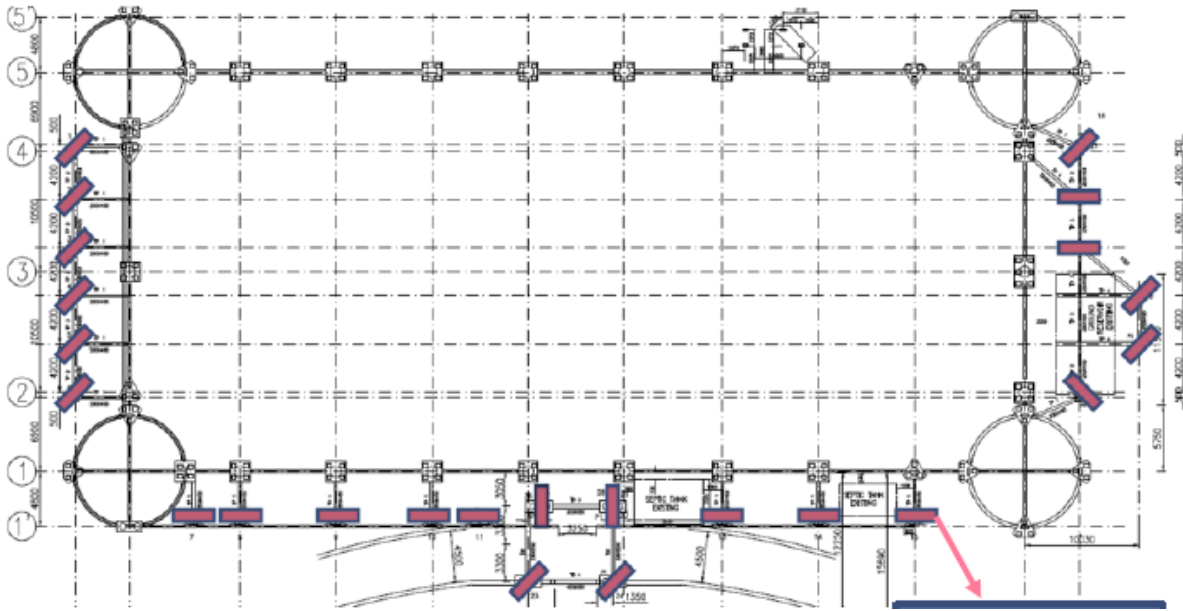
Figure 6. Strengthening with a new foundation

In principle, this system creates a new foundation as indicated in Figure 5 to support the old foundation. This is in the form of a bore pile with 30 m depth which was designed and implemented using an underpinning system as indicated in Figure 6 based on several considerations such as the limited workspace, not being noisy, and not disturbing the operation of an office building. This makes it possible for the structure to protect the old foundation and the structure it carries from the subsidence damage due to changes in soil conditions. Moreover, all the points of the foundation were reinforced but the repairment cannot be quickly conducted due to the limited field conditions which led to a longer period of work.

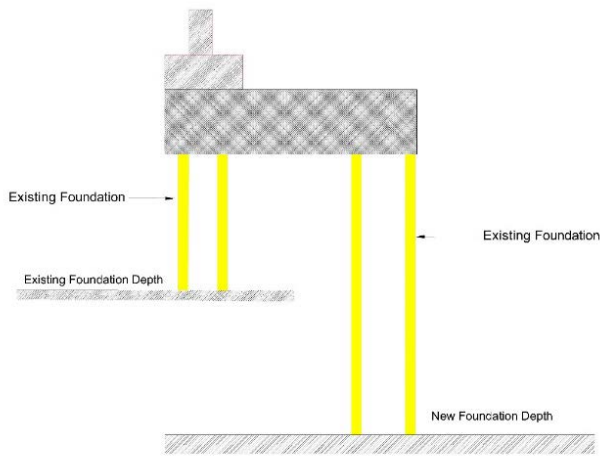
Figure 7. Underpinning method for strengthening existing foundations
