# RETROFITTING REINFORCED CONCRETE BEAMS USING CARBON FIBER REINFORCED POLYMER SHEETS AFTER EXPERIENCING FLEXURAL CRACKING DAMAGE

*This study investigates the retrofitting of reinforced concrete beams that have experienced flexural damage due to overloading using Carbon Fiber Reinforced Polymer (CFRP) sheets. The tested beam had previously developed flexural cracks and tensile steel yielding but had not reached complete collapse, indicating the presence of residual structural capacity and ductility. Prior to strengthening, the existing cracks were repaired using Sikadur-31 CF epoxy to restore continuity in the damaged region. Subsequently, CFRP sheets were externally bonded along the tension face to enhance flexural performance. Experimental testing was conducted using a two-point loading system to evaluate load–deflection behavior, crack propagation, stiffness, and failure mode before and after repair and strengthening. The results showed that the retrofitted beam achieved a significant improvement in structural performance. The maximum load capacity increased by approximately 20.47%, accompanied by enhanced stiffness, while the ultimate deflection remained nearly unchanged. This

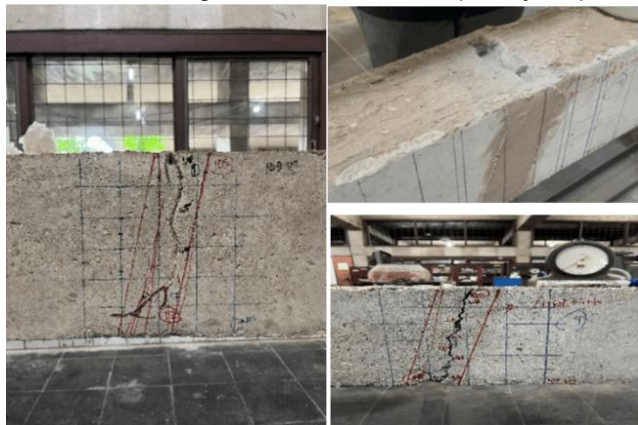
**Figure 9.** Chiseling around the cracked area of the beam specimen

The chiseling process served two main purposes. First, it created a rough and clean surface, which is necessary to improve the bonding quality of the repair and strengthening materials. Second, it opened the concrete pores and crack paths, allowing the epoxy material to penetrate and fill the damaged zones more effectively. In this study, chiseling was performed around both major cracks in the tension zone of the

beam as shown in Figure 9. The chiseled groove had an approximate width of 2.5 cm and a depth of 2 cm. This preparation facilitated epoxy application and helped ensure that the crack region was filled as completely as possible.

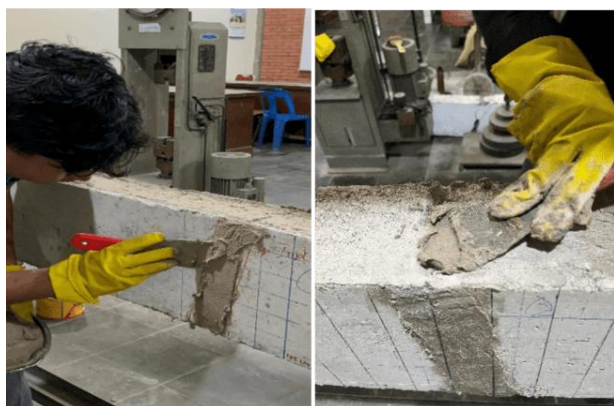
**Figure 10.** Application of Sikadur-31 CF epoxy to the cracked zone

Before applying the epoxy, the cracked area was cleaned thoroughly to maximize the effectiveness of the repair process and to ensure proper adhesion. The repair material used was Sikadur-31 CF, prepared by mixing component A and component B in a 2:1 ratio until a uniform mixture was obtained. From Figure 10, It can be seen that the epoxy was then applied into the crack grooves using a scraper, which functioned both as a filling tool and as a means to level the material evenly over the repaired zone. The application process was adjusted to the width and depth of the chiseled area so that the epoxy could fill the crack cavity thoroughly. The repair stage had to be performed carefully to ensure that the crack voids were fully filled and that no leakage or unfilled portion remained in the damaged zone. The installation of the CFRP sheet was conducted after the beam crack repair using Sikadur-31 CF had been completed. In this experimental program, the CFRP was installed one day after the repair process.

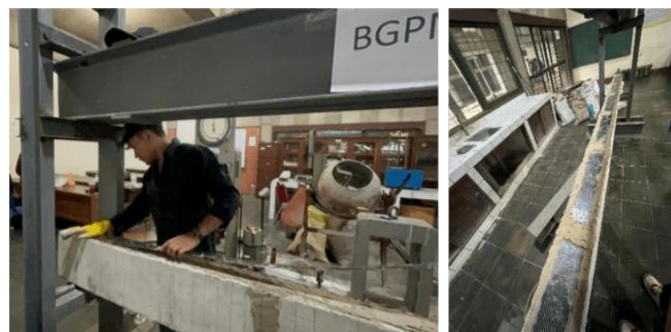
**Figure 11.** Installation process of CFRP sheets on the beam specimen

1. The tension surface of the reinforced concrete beam was cleaned thoroughly to ensure good adhesion between the concrete substrate and the CFRP sheet.
2. Sikadur-31 CF epoxy was applied over the entire tension surface of the beam to act as the bonding medium between the beam and the CFRP sheet.
3. The epoxy thickness was maintained at approximately 2–3 mm to achieve adequate bonding and load transfer.
4. The CFRP sheets were then attached to the beam surface, with an overlap length of approximately 2.5 cm at the joint between adjacent CFRP segments to improve continuity and structural performance.
5. Additional epoxy resin was applied in the overlapping region to reduce the risk of premature failure or debonding at the CFRP joint.
6. After installation, the beam was left to cure for approximately 24 hours, depending on the type of epoxy used and the ambient temperature.

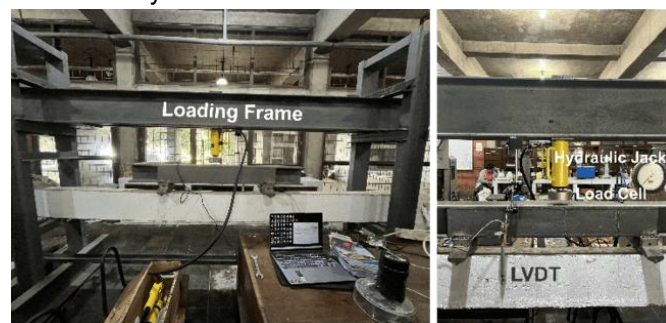
**Figure 13.** Experimental test setup

The beam was supported on a pin-roller support system, with each support located 10 cm from the beam end. Above the beam, a steel IWF loading beam measuring 150 cm × 14 cm with two loading

legs of 3 cm diameter was placed. The spacing between the two loading points was 90 cm, and the total weight of the steel loading beam was 76.85 kg. The purpose of this steel loading beam was to convert the single-point load from the loading frame into a two-point loading configuration acting on the test specimen. To measure beam deflection, Linear Variable Differential Transformer (LVDT) sensors were installed. The LVDT is a device used to measure the linear displacement of a structure with high precision by converting linear movement into a proportional electrical signal. The overall test setup and the installation of the sensors are presented in Figure 12 and Figure 13.

In this study, loading was terminated when the CFRP sheet experienced failure or when debonding occurred between the CFRP sheet and the concrete beam surface. This termination criterion was selected because the objective of the test was to evaluate the effectiveness and failure behavior of the repair-and-strengthening system rather than the beam alone. The flexural test setup using the hydraulic jack, LVDT, Load-Cell, Loading Frame are shown in Figure 14.

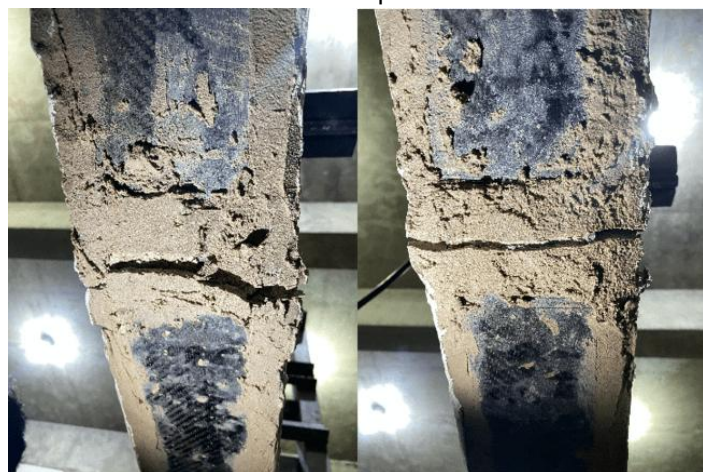
**Figure 17.** Debonding failure of CFRP

When the beam reached a deflection of approximately 40.9 mm, failure of the CFRP strengthening system occurred by progressive debonding and eventual local rupture/damage as shown in Figure 17. The failure began with loss of bond at the adhesive interface and developed gradually rather than instantaneously. This failure mode is highly significant analytically. Externally bonded FRP systems often depend not only on the tensile capacity of the FRP itself, but also on the integrity of the bond between the FRP, adhesive, and concrete substrate. ACI 440 specifically recognizes the importance of material properties, installation quality, and bond behavior in determining the effectiveness of externally bonded FRP systems. In the present beam, the debonding-type failure suggests that the strengthening system had mobilized substantial tensile force before failure, which is why the beam could achieve a higher ultimate load than the original specimen.

Equally important, the beam did not fail in a sudden brittle collapse immediately after debonding started. Residual force transfer remained available for a short period, and the beam retained its overall shape. This implies that the CFRP system had already delivered meaningful strengthening before bond failure, and that the final failure process was progressive enough to be structurally observable rather than catastrophic.

However, the study also found that the joints between the separated CFRP segments became a weak point in the strengthening system. Failure at the CFRP segment joints was observed, highlighting the need for further attention to this issue in CFRP applications in the field. Additionally, while the beam's capacity increased, design considerations should be made to ensure that the beam still experiences tensile failure, rather than brittle compression failure due to the high tensile strength of the CFRP.
